Tower of Hope

at Christ Cathedral

Renovation, Engineering and Construction by California Waters
Landscape Architecture by LPA, Inc.

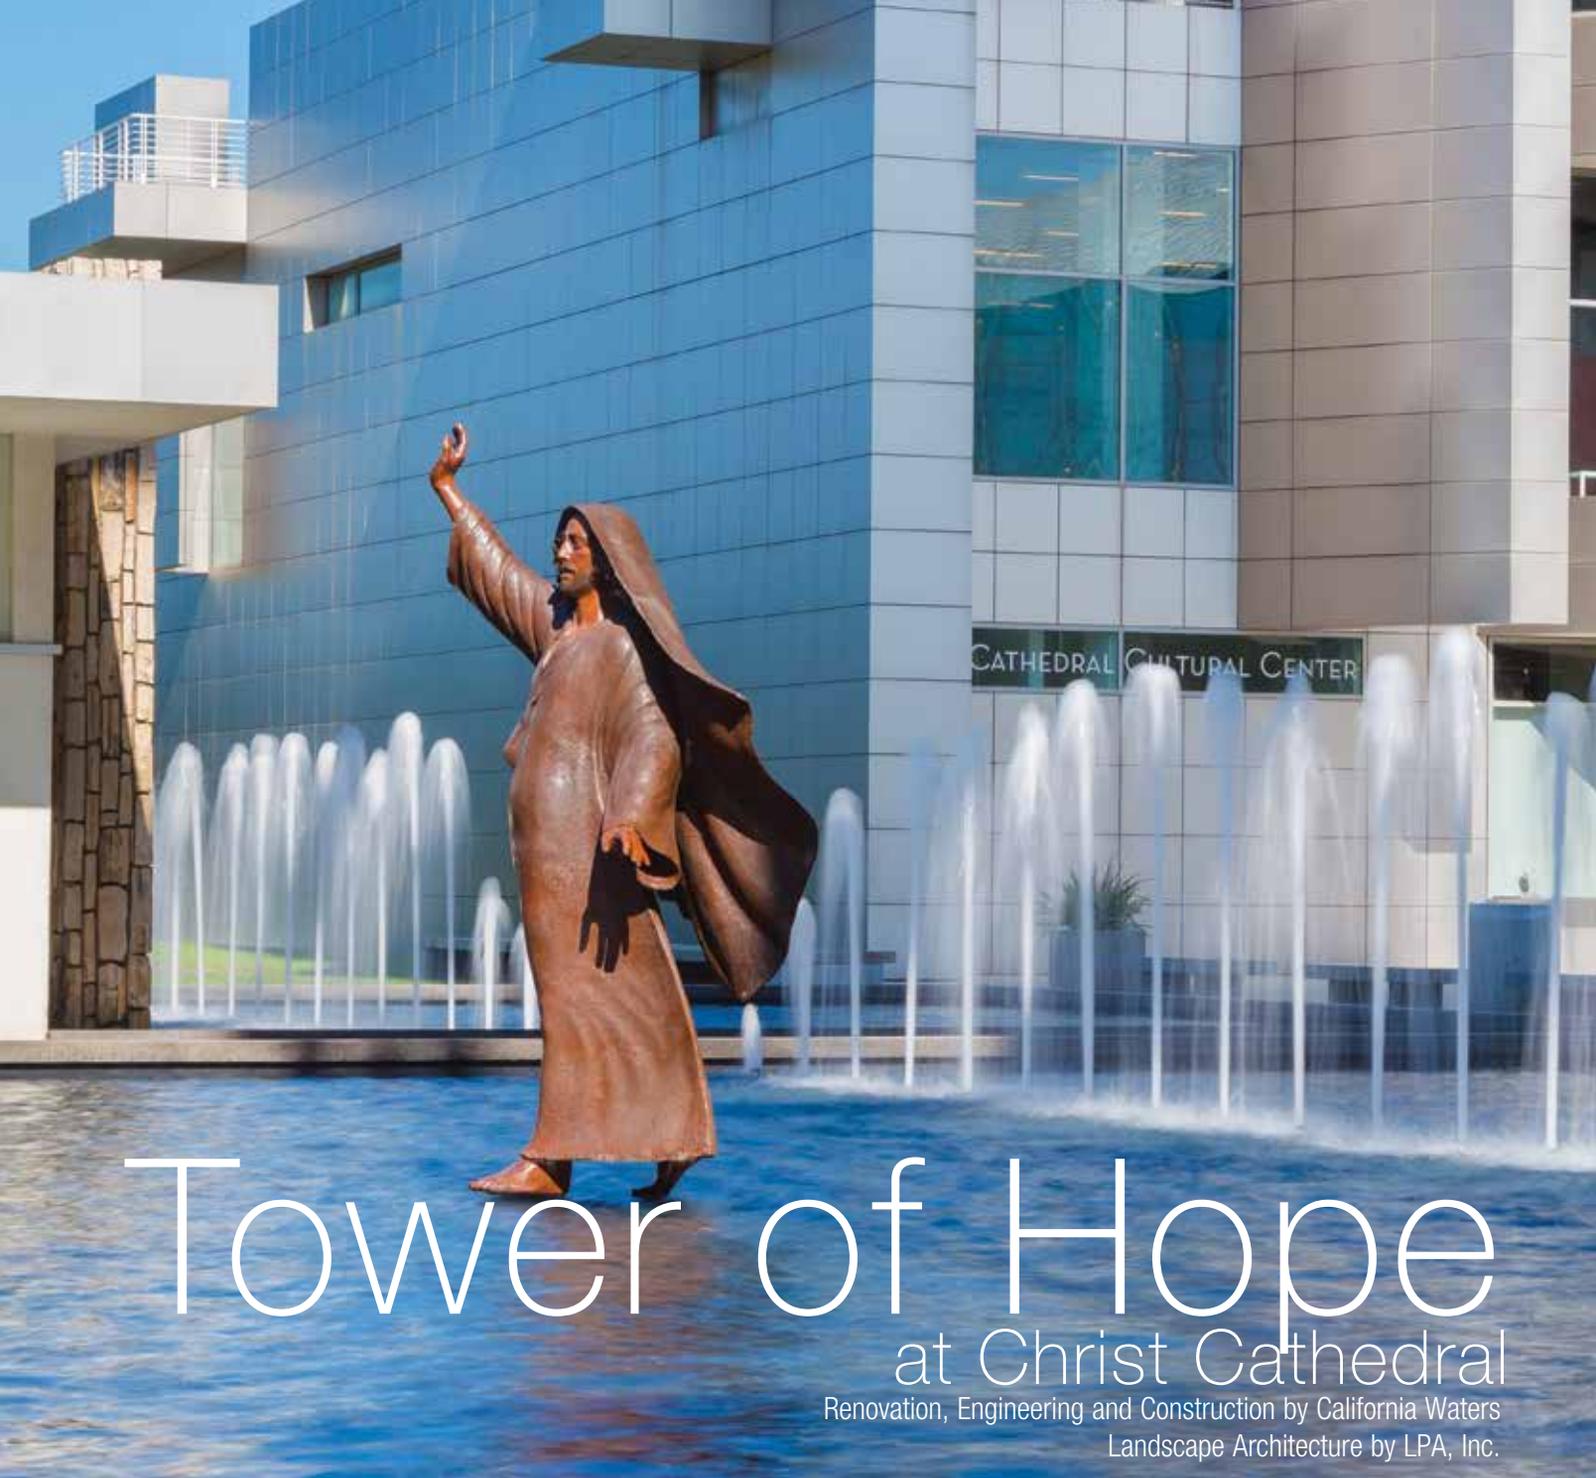
Above

Christ Cathedral, located in Garden Grove, Calif., was until recently known as the Crystal Cathedral. The site was renamed after the Diocese of Orange purchased it in 2012. The 15-story Tower of Hope was built in 1968 to accommodate offices and classrooms for the church. The tower is set off by a 1,500-pound cast bronze sculpture of Jesus walking on water ("Peace Be Still," Dallas Anderson, 2000), with a flanking "chorus" of fountains behind. California Waters of Yorba Linda, Calif., designed, engineered and constructed the water feature; LPA, Inc., of Irvine was the landscape architectural firm.

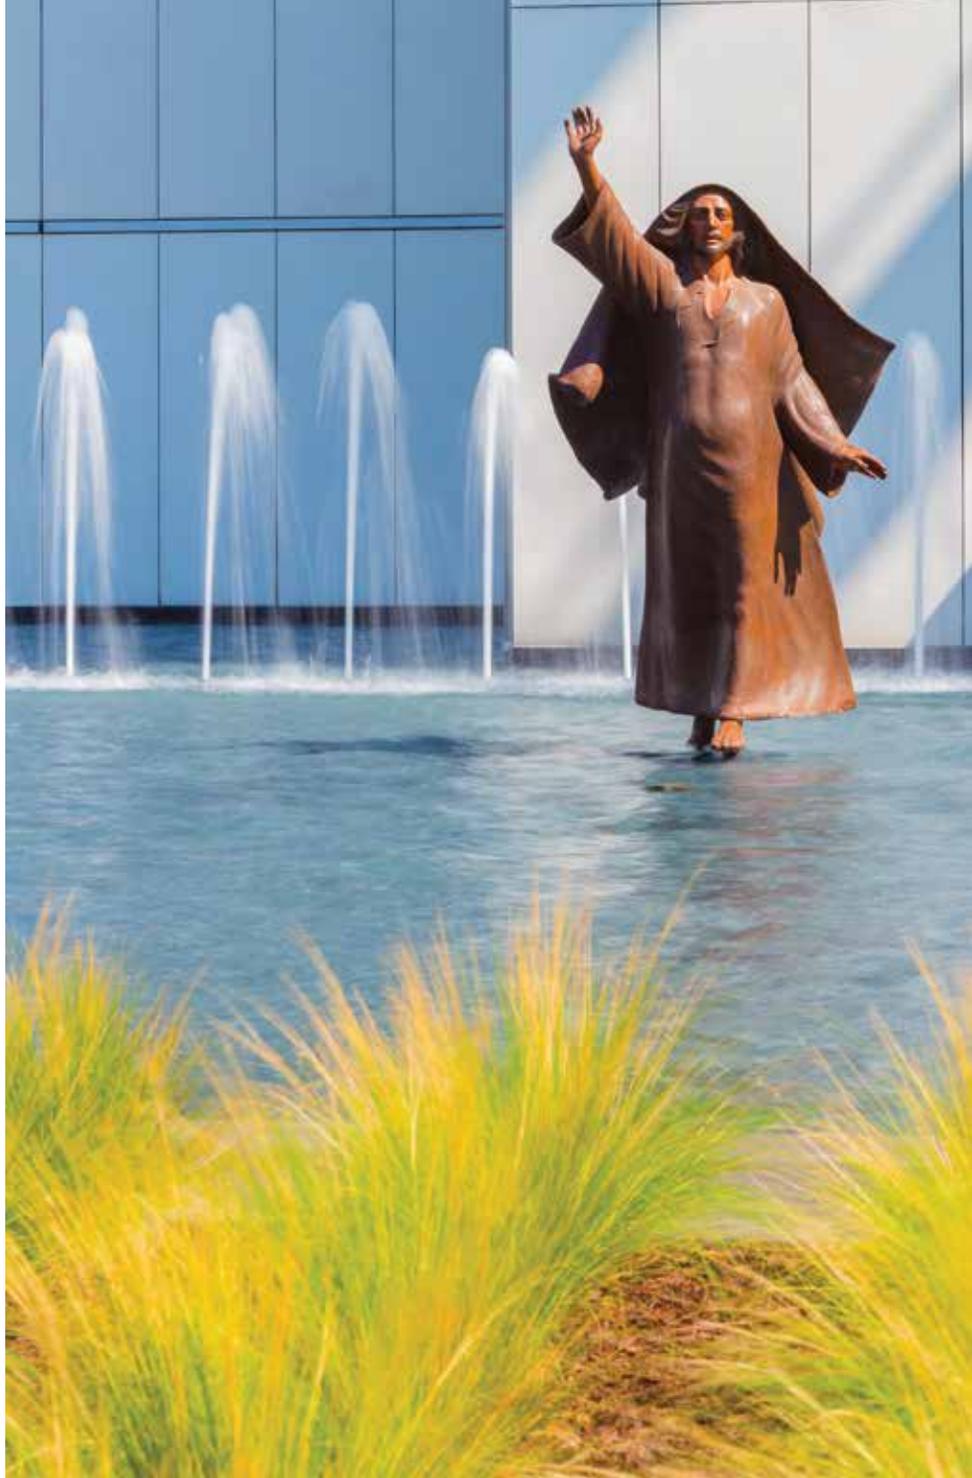
Above

The main goal of the renovation was to bring the outdated fountain, which encompasses two 5,800 square foot reflecting pools that hold 65,000 gallons of water, back into service and into this century. The process involved addressing water treatment and filtration issues, leaks, and patchwork repairs made over the last forty-five years. Over 6,500 square feet of a waterproofing membrane was applied to the structure to eliminate leakage and give the look of a rough ocean.

The makeover started by adding over 6,500 square feet of black waterproofing to the floor of the reflecting pool to eliminate leakage and give the appearance of a turbulent sea. Extensive new concrete was formulated to maintain the aged look

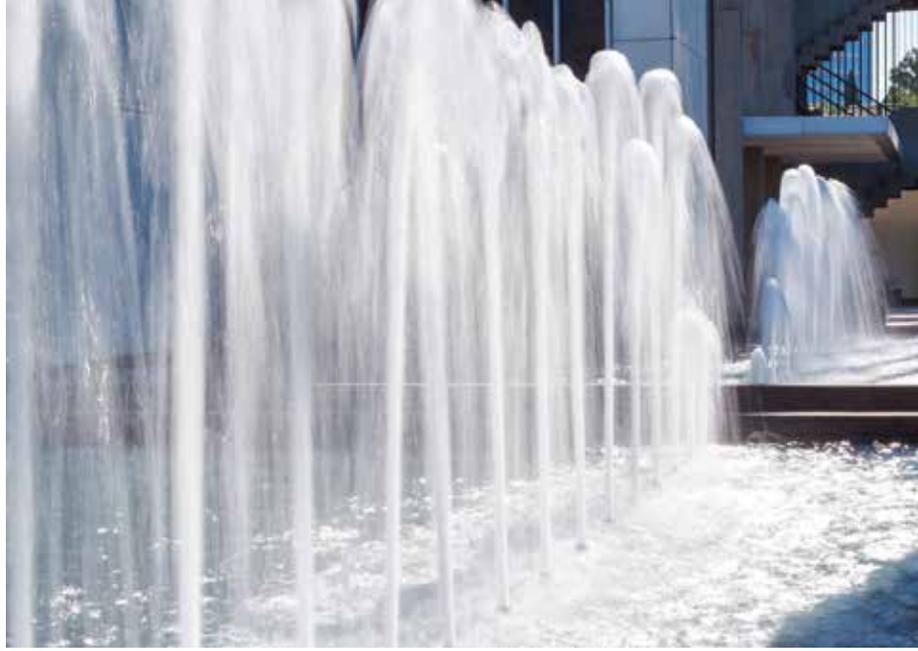
Top, Right

Inspired by Moses parting the Red Sea, a total of 32 fountain nozzles are divided by a concrete walkway. Post-renovation, the footprint of the nozzles was kept the same, but upgrades were made to minimize splashing onto the path. Ball valves were incorporated in the nozzles closest to the concrete so the jets of water can be cranked down. Additionally, all the nozzles were equipped with wind sensors, so as the wind picks up, the height of the fountains lowers proportionately to diminish splashing. The maximum height for any jet is 10'.

of existing sidewalks and surrounding concrete. All water feature systems and controls are now fully automated, including the water level system. The spacing of the nozzles had to match the original layout, in which the fountains splashed over the walkway. A ball valve was incorporated to allow the nozzles closest to the walkway to be cranked down to minimize splashing. The nozzles are also tied to a wind sensor – as the wind picks up, the height of the nozzles lower in real time. Nineteen LED lights were selected to match the warmth of the existing surrounding night lighting. A highlight of the renovation is the production of a memorable shadow effect on the tower as day turns to dusk and the lights come on.

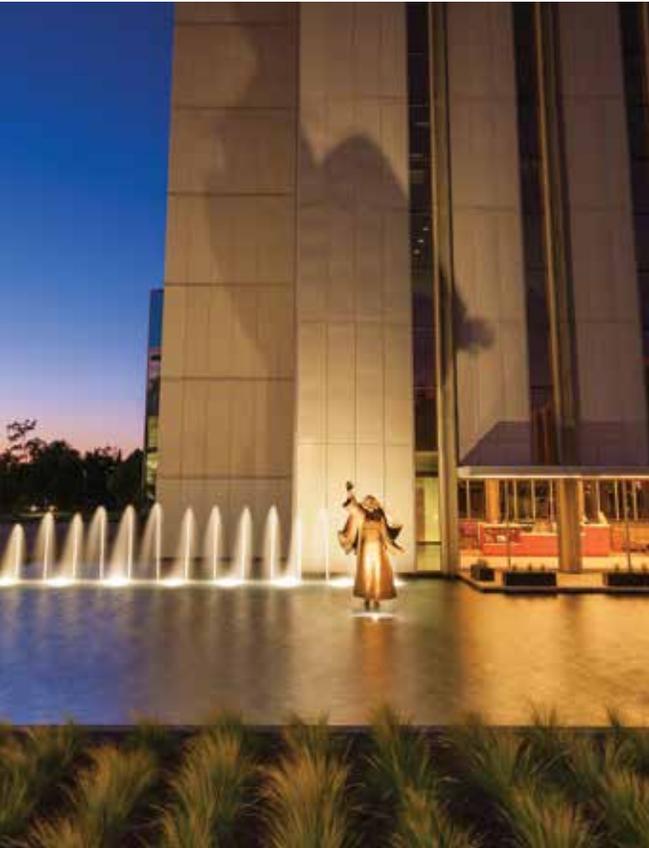
Above

Nineteen LED lights flank the tower, the fountains, and the sculpture. They were specifically chosen to coordinate with the existing surrounding landscape and architectural lighting. The shadow effect created by the LEDs is one of the highlights of the renovation.

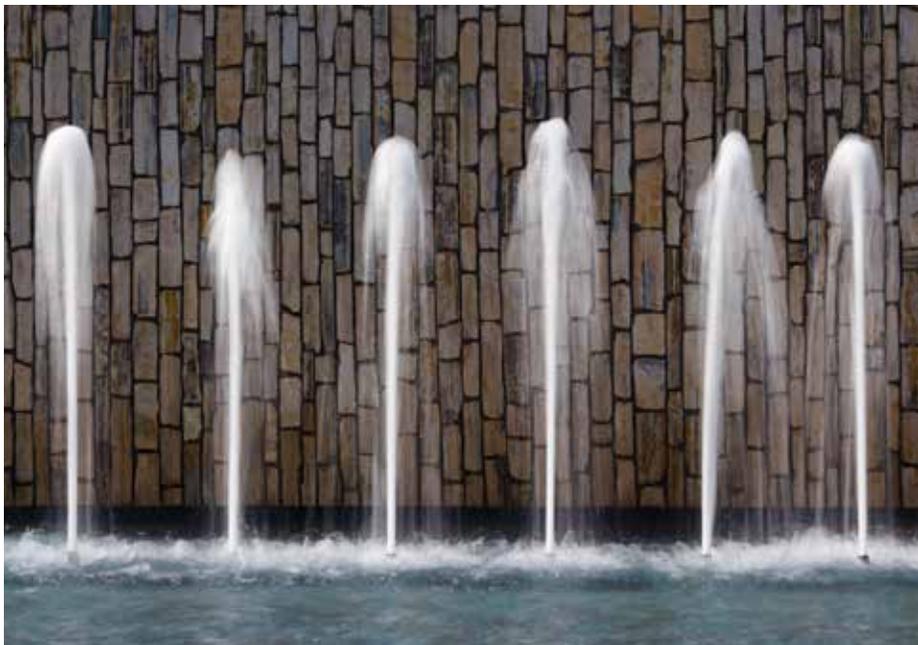
Bottom, Right

The new owners requested that the water appear to be directly against the buildings, without actually touching them or needing a concrete barrier between the water feature and building. The solution incorporated thin stainless steel built into the pour along the perimeter where the feature meets the tower. Though it was difficult to design and install, the desired effect was achieved.

One major design challenge involved the clients desire for the water to appear as though it is directly adjacent to the existing tower without pouring a concrete barrier along that side of the feature or tying into the building. California Waters' solution incorporated a large, thin, stainless steel angle, built into the pour along the perimeter feature where it meets up with the tower. This approach was complicated to design and tricky to install, but the finished result was flawless.
